Minerals Inspection Report

Mine Name: Tusher Redwood	Permit Number: S/019/0061	Mine Status: Reclaimed
Operator Name: Larry Walker	Inspection Date: 08/27/2014	Permit Fees: No Fee Req.
Inspector(s): M. Bradley	Inspection Time: 9:00am	Bond Amount: \$1,000
Attendee(s): Doug Rowles, BLM	Weather: Cloudy, mild	Bond Escalation: N/A
Inspection Purpose: Operator requested bond release		Prior Inspection: 05/06/2014

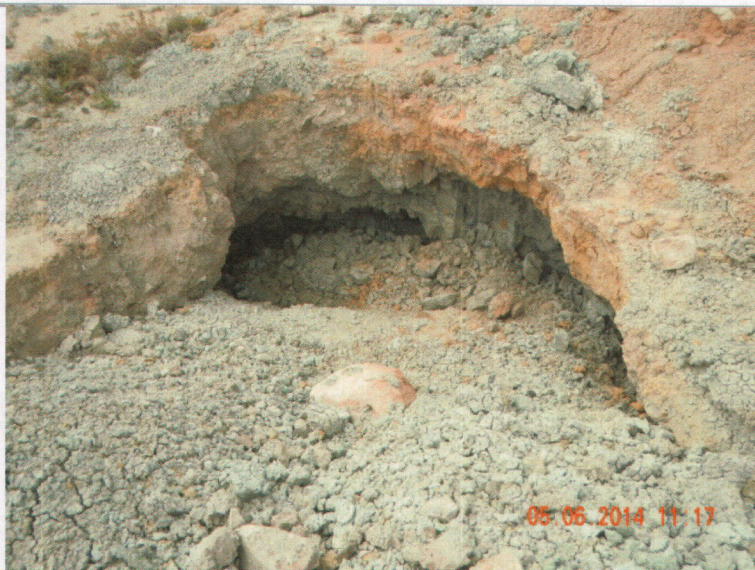
Hole as seen in May, 2014

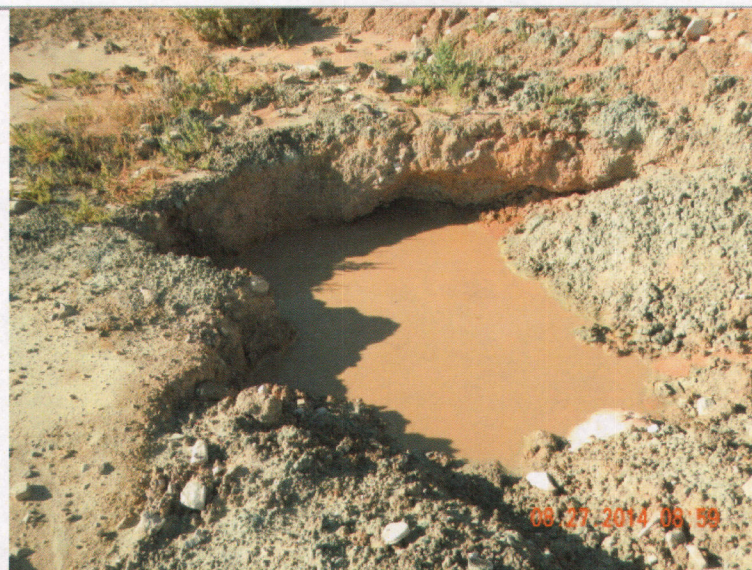
Location: 607527.00 m E, 4285532.00 m N, UTM Zone 12N. Went back to site with Doug Rowles, BLM, to attempt to backfill hole created by rock club on previously graded site. Upon arrival, hole was full of water from recent rains. Backfilled hole as best we could with soil and rocks. We couldn't see the back cavity, but we believe we were able to backfill it to the point where it would take some work for someone to reopen it and the potential safety hazards were alleviated. According to the accepted NOI, revegetation standards were minimal as little to no vegetation existed prior to disturbance. With concurrence from BLM, recommend releasing remainder of bond.

Hole as found on August 27, 2014. Full of water from recent rains.

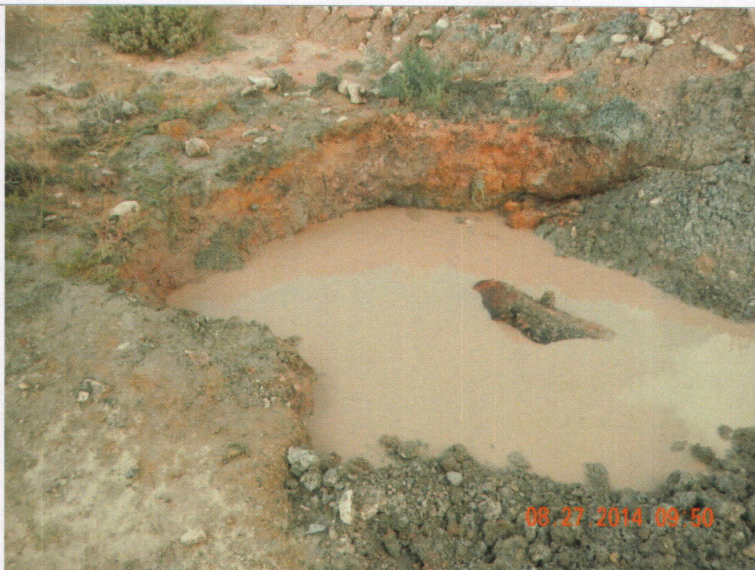
Hole after backfilling with excavated material and rocks

2. <i>Public Safety (shafts, adits, trash, signs, highwalls)</i>	<input checked="" type="checkbox"/>	<input type="checkbox"/>
Backfilled hole dug by a club of rock collectors

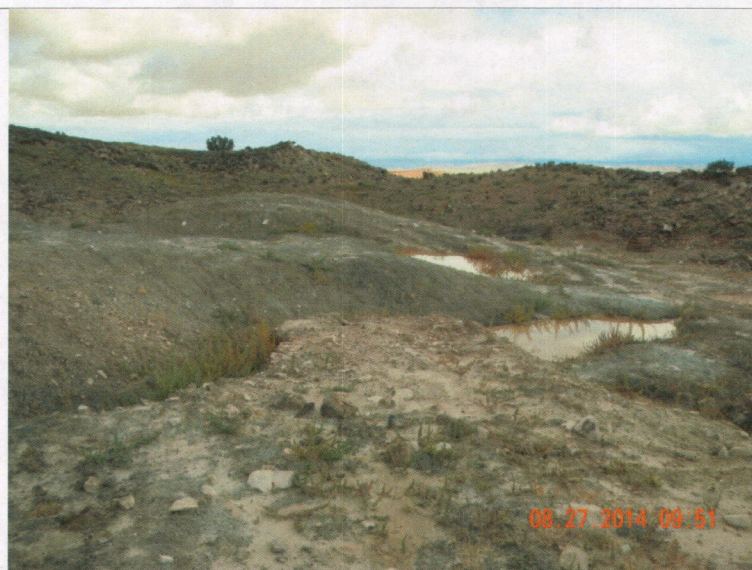
Rest of Cast Claim area
